## CE-marked Commercial Diving Recovery Harness

**Part No:** HA-014

# JOK Diver Recovery Harness Mk2

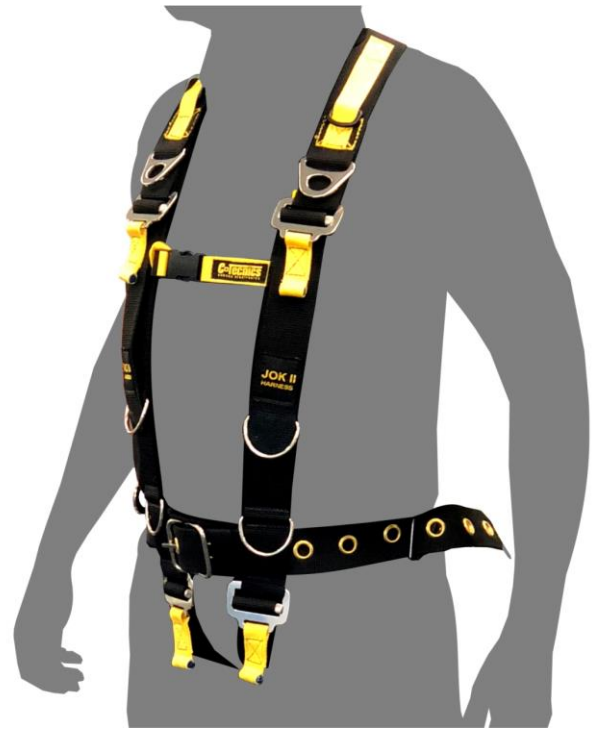
It is important to differentiate between certified lifting points and lightweight tool attachment points and the special profile-cut 'D' rings make no doubt which to use, and assist the diver in poor visibility or stressed conditions. The Umbilical connection point is also load tested, but is adjustable as to its position, which allows divers of different sizes to slide it into position and lock it in the most suitable place – another bit of diver feedback, and how to do it is a great idea from our design team.

The Jok II harness was tested at 900Kg/N with no failure of stitching or webbing, in line with the requirements of harmonised standard BS EN15333:2008. The special profile cut 'D' rings were selected to overcome any doubts which may occur when using normal welded 'D' rings for lifting purposes as we uncovered that the manufacturers of these traditional items would not load certify them as they could not guarantee the weld quality.
